SUBJECT John Anglin, Clarence Anglin and
Frank Lee Morris Escape from Alcatraz

FILE NUMBER 76-26295

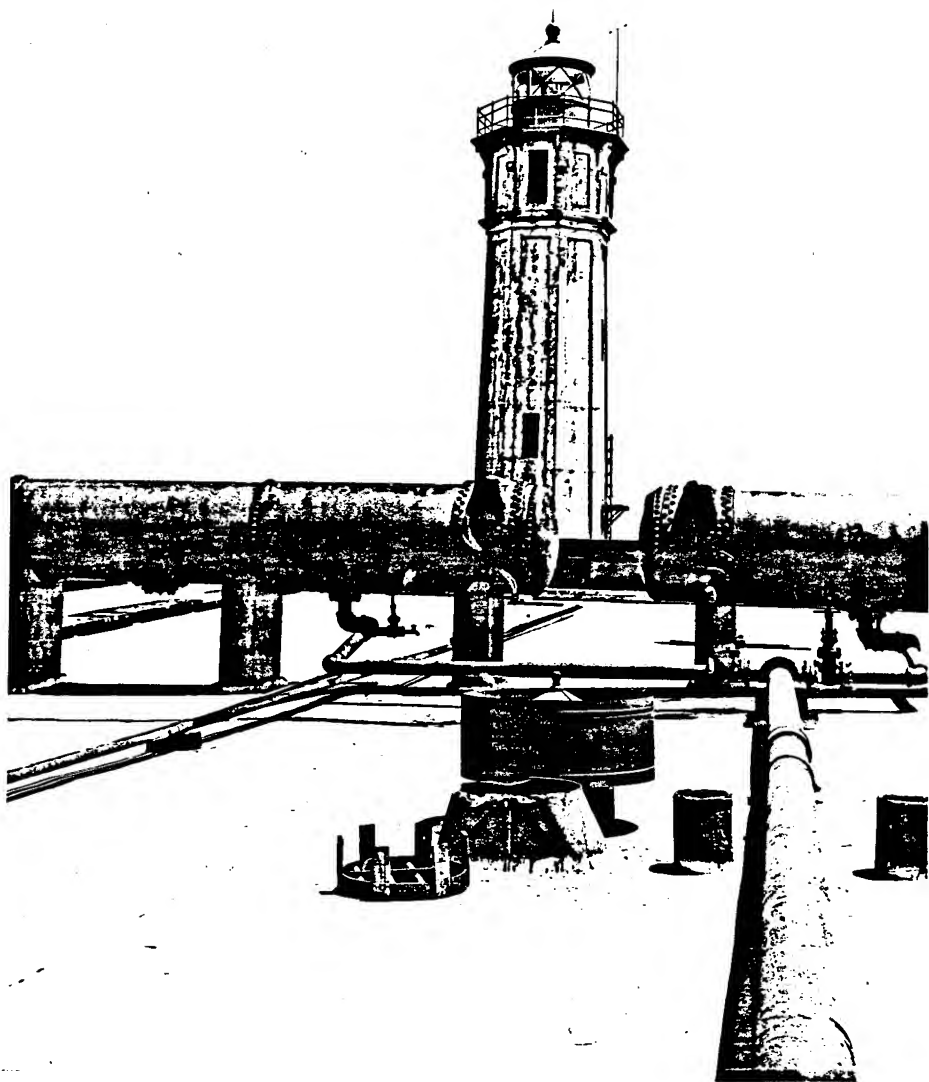
1-6 Photograph taken on the top of building comprising Cell Block B looking in a southeast direction showing general view of building top with the Coast Guard lighthouse center rear. This lighthouse is not manned except in cases of emergency.

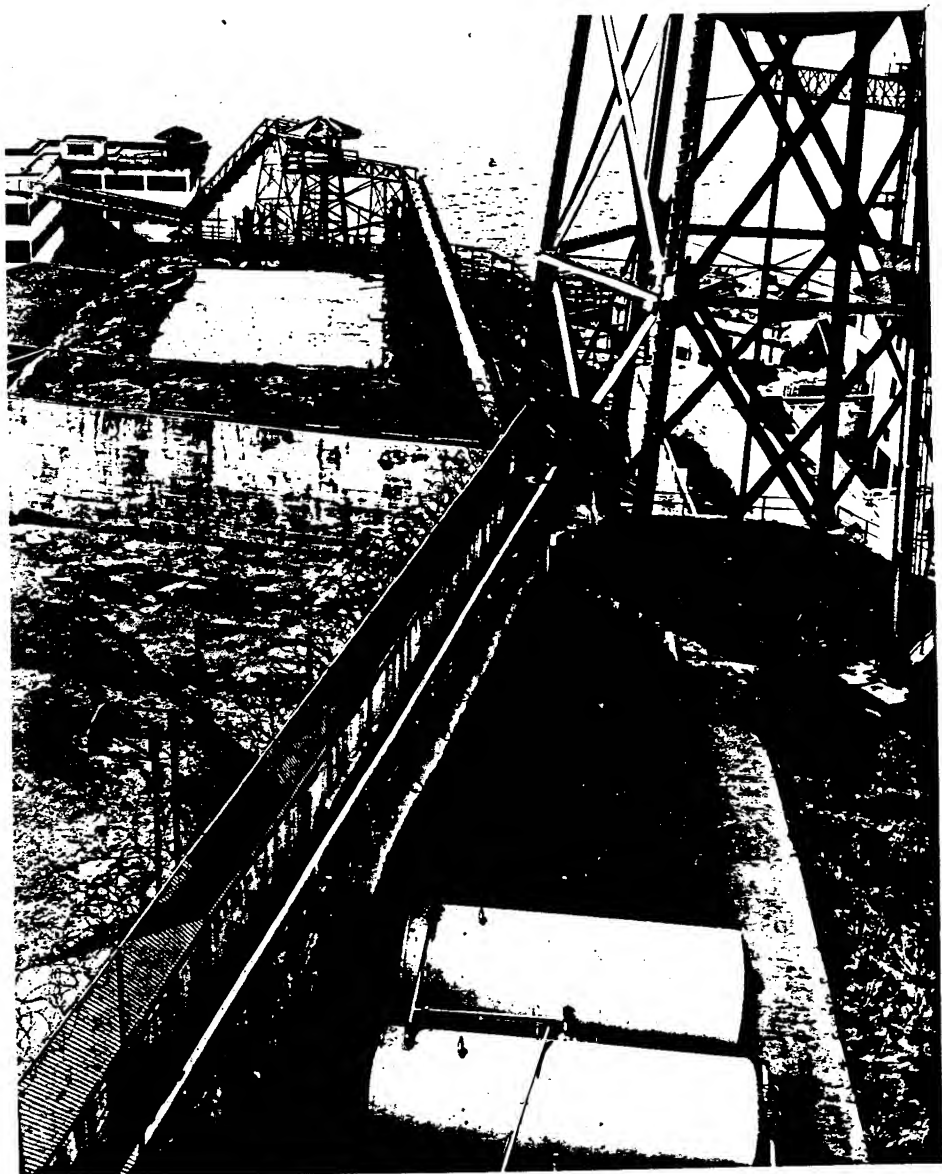
2-2 A general northern view taken from the top of the prison building. The area immediately to the left and center is the recreation area and at the far end may be seen guard tower number 4 and guard tower number 3 and guard tower number 2. None of these guard towers are manned during the night.

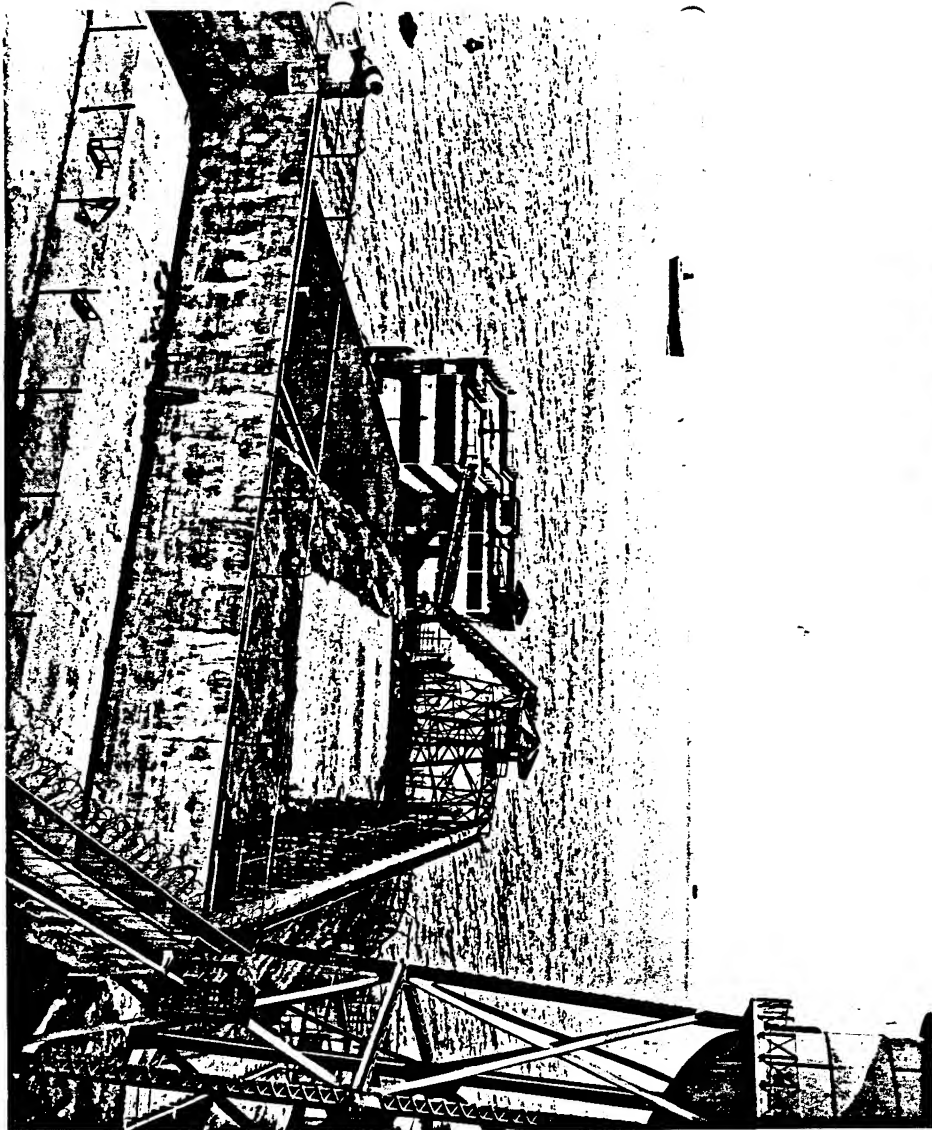
2-3 Same general view as 2-2 except that a larger portion of the recreation area is visible.

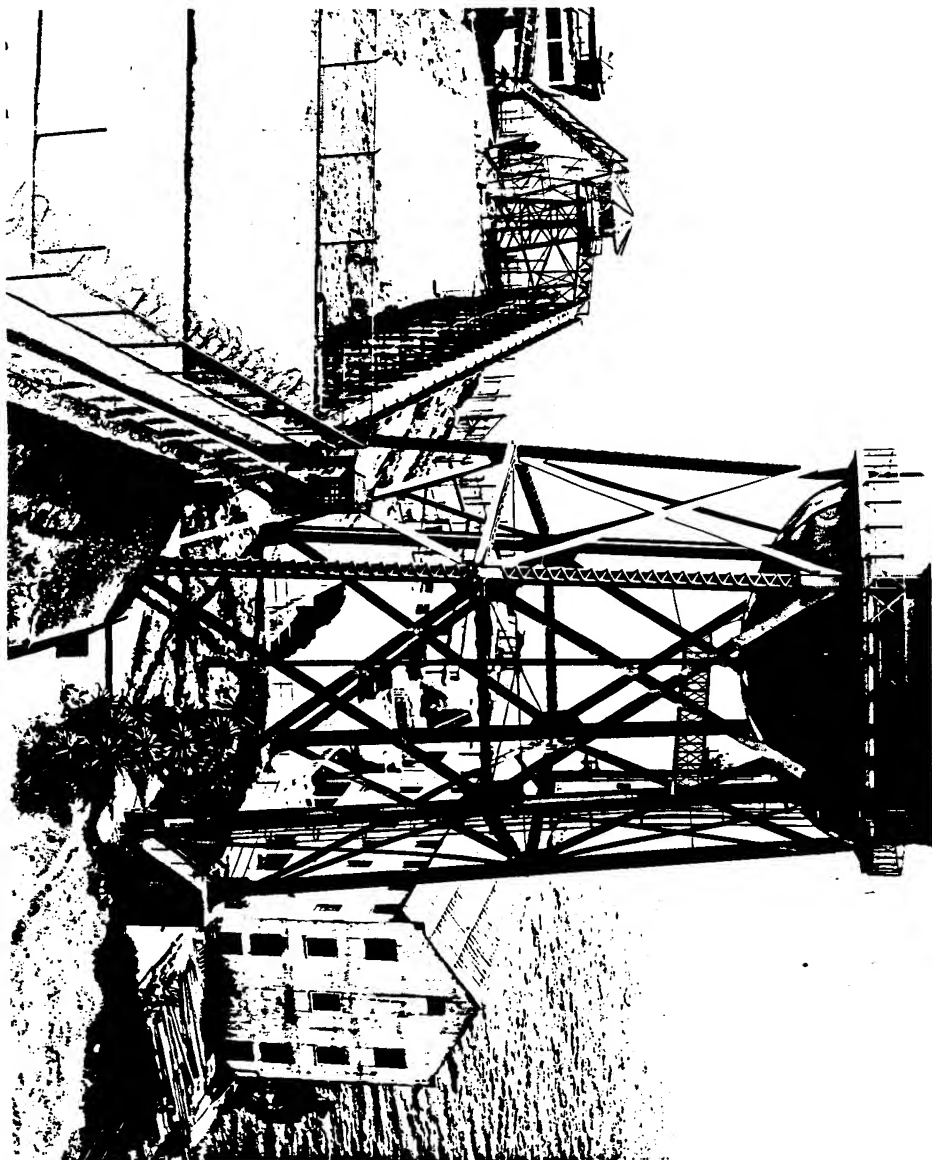
2-4 Same General view as previous photographs with the exception that the industrial building is shown in more detail.

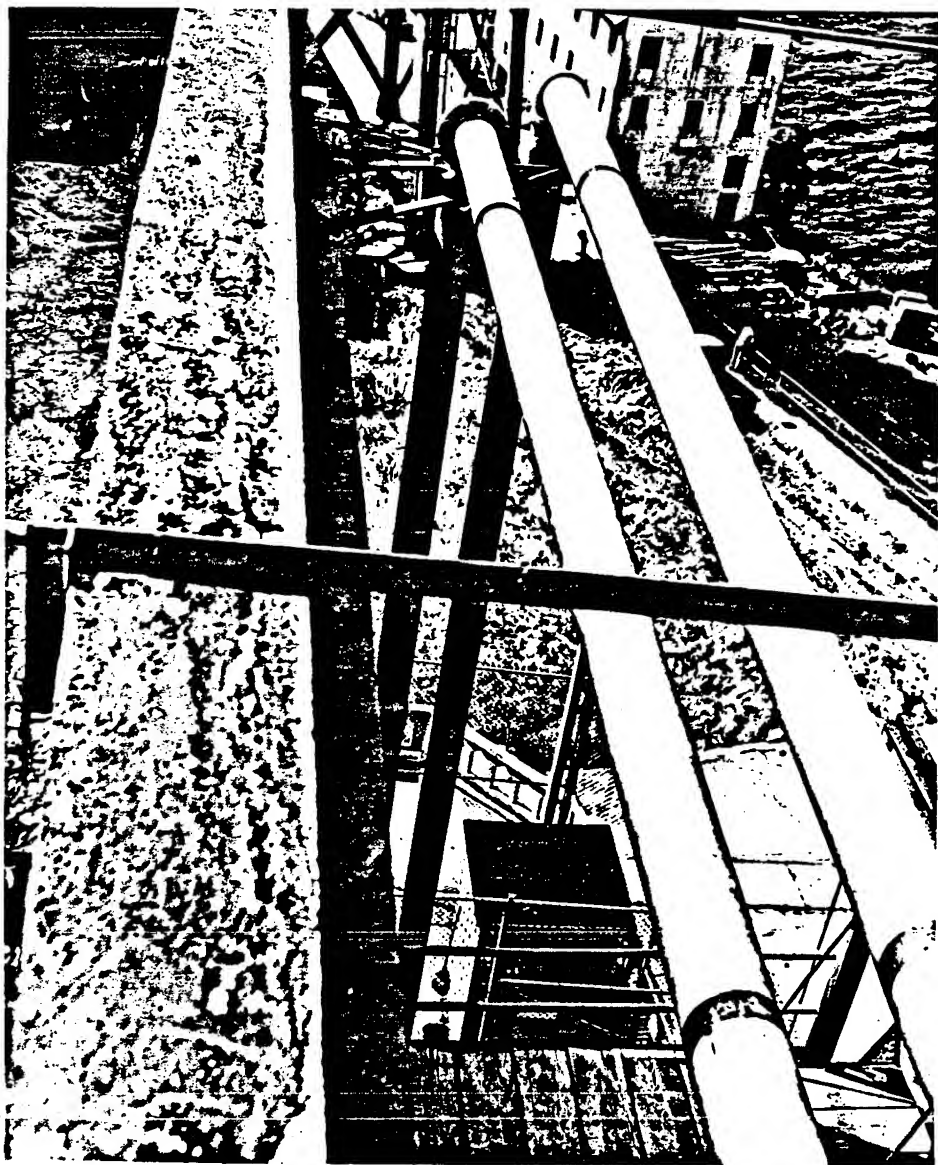
2-11 Photograph taken from roof of building at the northeast corner showing aluminum-plated utility pipes descending to ground level. These pipes are approximately six inches in diameter. Lower center of photograph shows the landing outside of the third floor entrance to the prison building. Stairs lead from this landing to the ground level in the same area as shown in photograph 1-12, however this corner of the building is illuminated by three flood lamps and is clearly visible to the guard in tower number 1 which is manned twenty-four hours a day. The angle iron crossbrace shown in the center of the photograph is the type used to support the illumination. Upper left hand corner shows the type of electrical connection for these lamps.

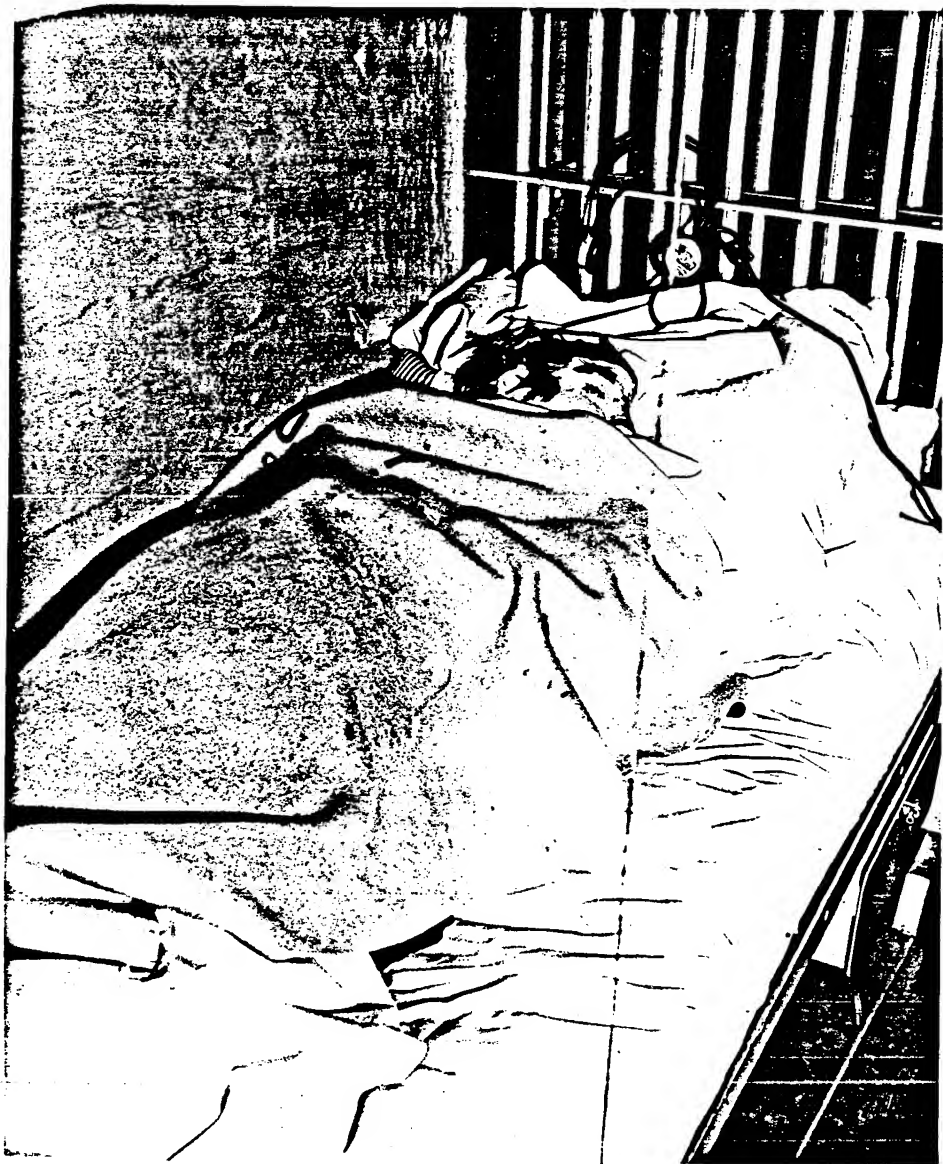
3-3 Photograph taken in Cell 152 B from foot of bed looking toward head of bed.

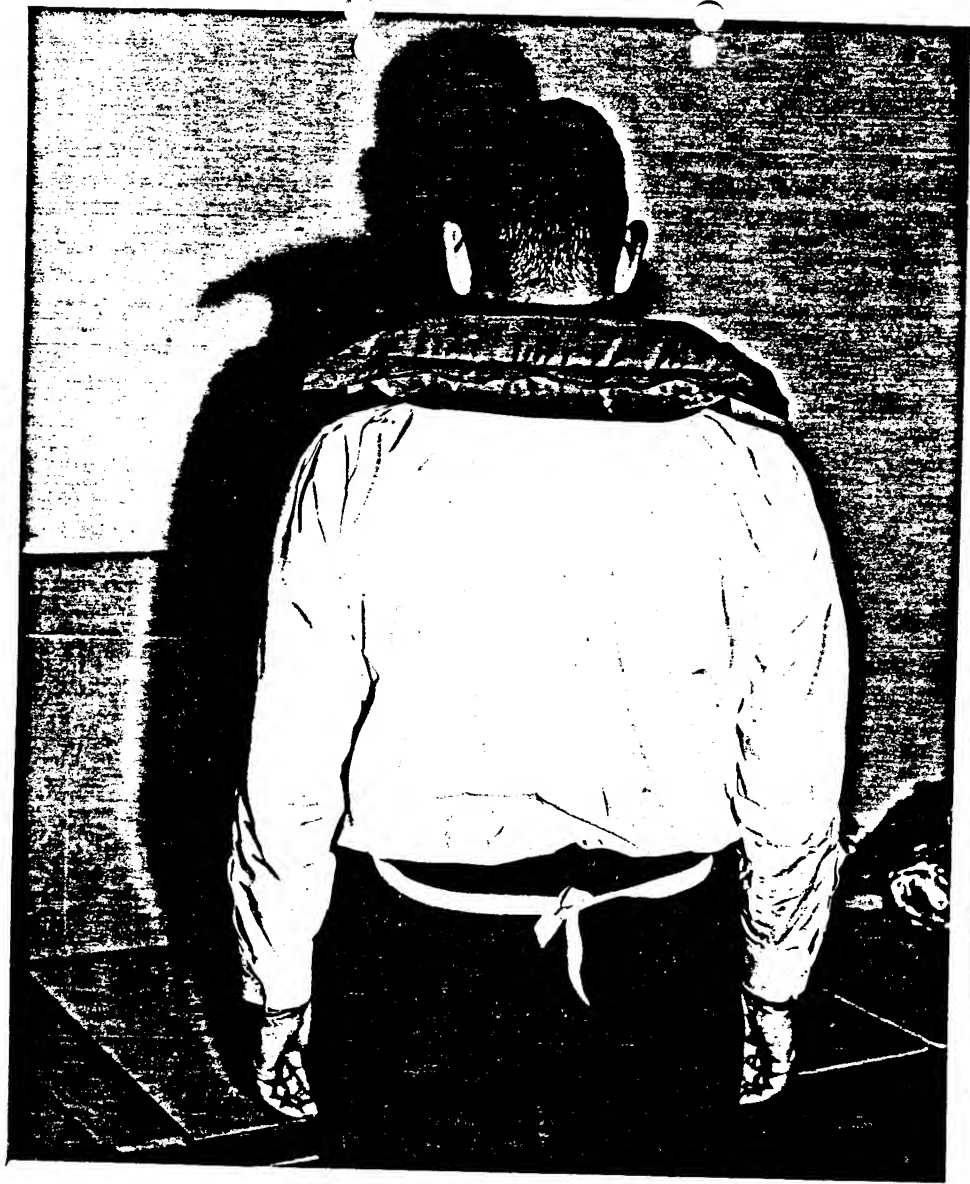
Rear view of yoke type vest being modeled by Special Agent.
